**Marine Surveys & Consultancy International**

**CONDITION SURVEY**

**Name of Vessel:-** "Sample"  
**Registration Number:-** TBA  
**Port of Registry:-** TBA  
**H.I. Number:-** FR-1R100588A303  
**Type of Vessel:-** Aux/Sail  
**Builder/Yard:-** Jeanneau (FRA)  
**Construction:-** GRP  
**Designer:-** Philippe Briand /Jeanneau  
**Place & Year Built:-** Les Herbiers, France, 2003  
**Length:-** 13.73m      **Beam:-** 4.49m      **Draft:-** 1.83m  
**Displacement:-** 21208 lbs./ 9620 kgs.      **Sail Area:-** 800 ft<sup>2</sup> / 74.32 m<sup>2</sup>  
**Gross/Net Tonnage:-** 18.05 Tons

**Location of Survey:-**      Afloat & Ashore  
Porto Touristic Marina di Ragusa, Sicily, Italy

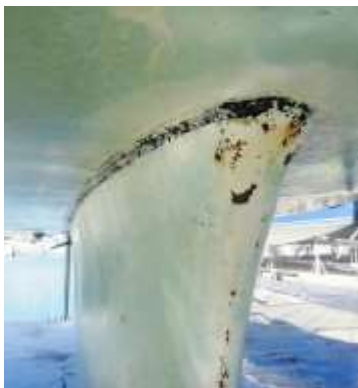
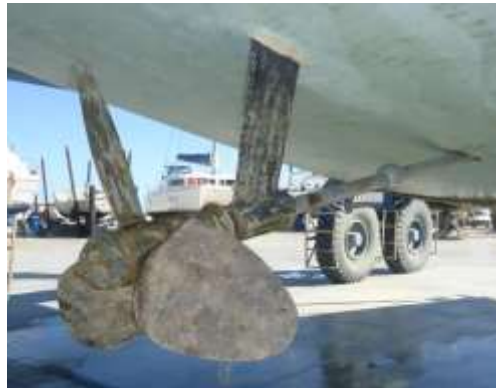
***No concerns noted regarding hull to keel joint (Note keel supported by timber block)  
Propeller greased & new shaft anode fitted while ashore***

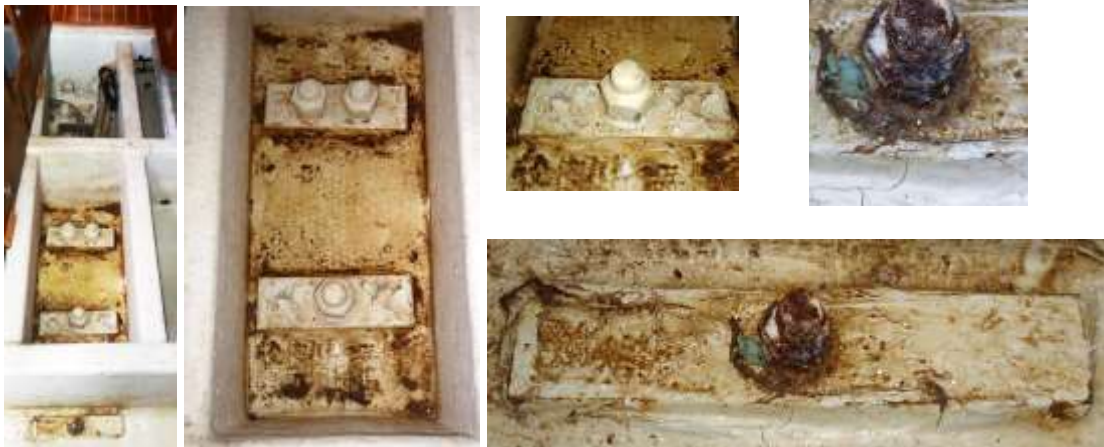
### Keel attachment

Access to this area requires the removal of the centre cabin sole. Please note the strengthening of the hull structure with fore & aft and athwartships beams.

It is evident that for a period of time bilge water has been standing in this area which has resulted in the aft 18mm keel stud and nut suffering from corrosion. This needs to be investigated and rectified at the next haul-out.

The main keel studs and nuts are 32mm and appear in good condition. The forward keel stud and nut has not been controlled need to the need to remove cabin furniture.

- 1) Investigated rear 18mm keel stud and nut and rectified at the next haul-out.
- 2) Clean bilges as priority.
- 3) Investigate and check forward keel studs and nuts.
- 4) Bowthruster propeller zinc anodes will require replacing at next haul-out.
- 5) Bowthruster missing guard rails to be replaced at next haul-out.
- 6) Investigate and rectify corrosion concerns on keel at next haul-out.

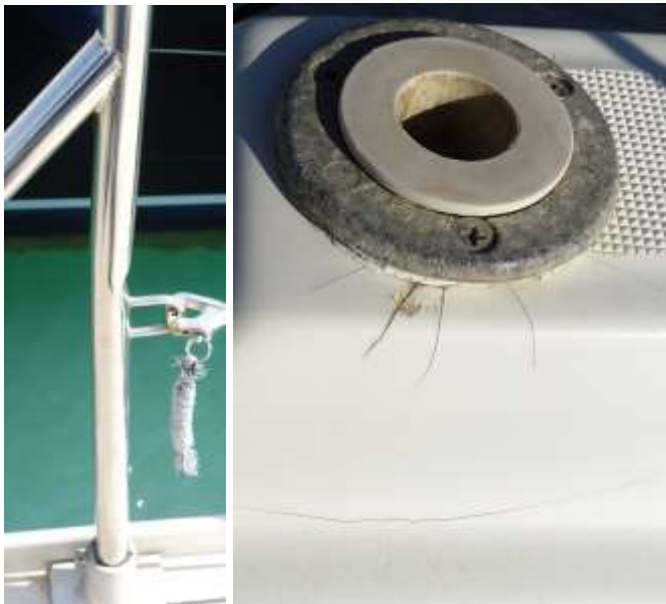
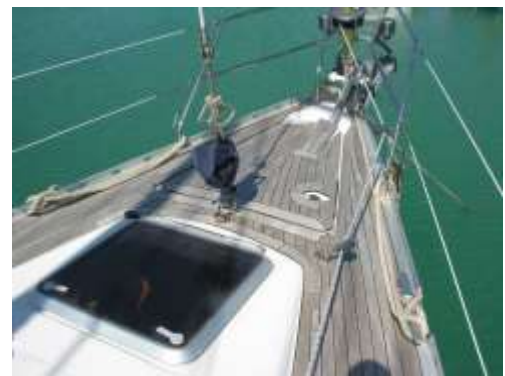
***Deck Damage concerns:***

*Retrofit passarelle mount has caused gelcoat and possible structure concerns*

*Damaged gate stanchion to starboard including bases.*

- Defects:-**
- 1) Investigate and rectify deck and gelcoat concerns
  - 2) Remove damaged stanchion got repair and re-install.

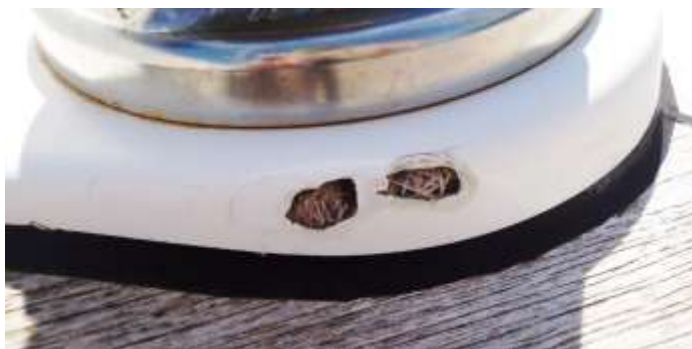
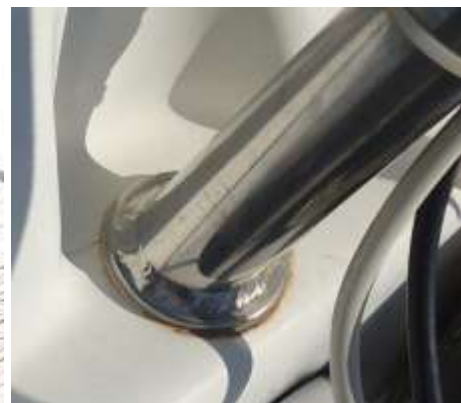
*Damage due to voids in original layup to port plus a stress crack; in regard to stern rail mount to starboard.*

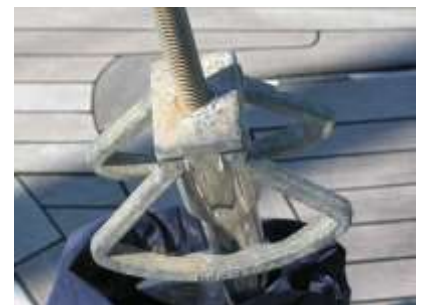
The inner forestay considered to be for a storm Jib  
This is removal to allow the foredeck to be clear when tacking.  
The tensioner is heavily corroded requiring overhaul or replacement.

- Defects:-**
- 1) Service rigging components as required.
  - 2) Due to age of the rigging survey by a qualified rigger is recommended.
  - 3) Upgrade combination deck/steamer light to meet international requirements to 20m.

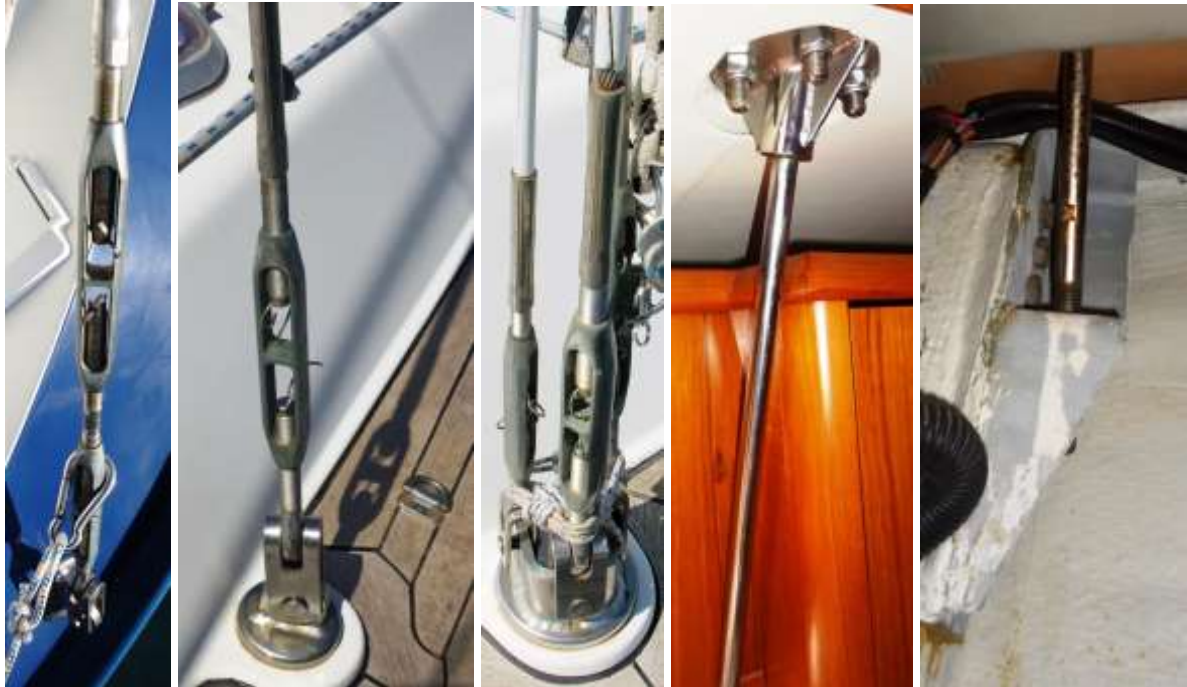
- ✚ Double turnbuckles utilized on backstays
- ✚ Split rings on turnbuckles suspect and rectification required
- ✚ Custom change plates
- ✚ Under deck support components
- ✚ Metal bracket to accept support rod bolted to hull string point.

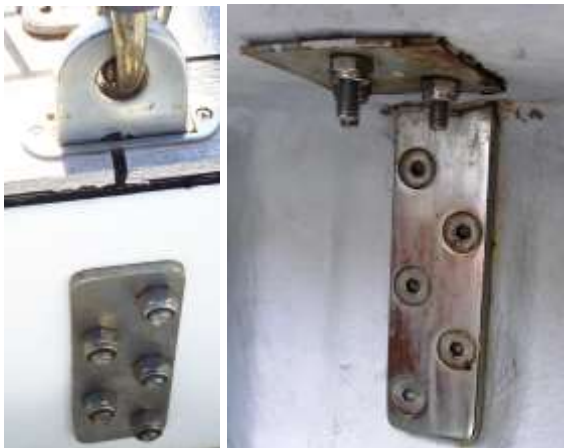
- ✚ Inner forestay chain plate details
- ✚ Evidence of water ingress observed. Investigate and rectify as required.
- ✚ Minor rigging wire corrosion noted.

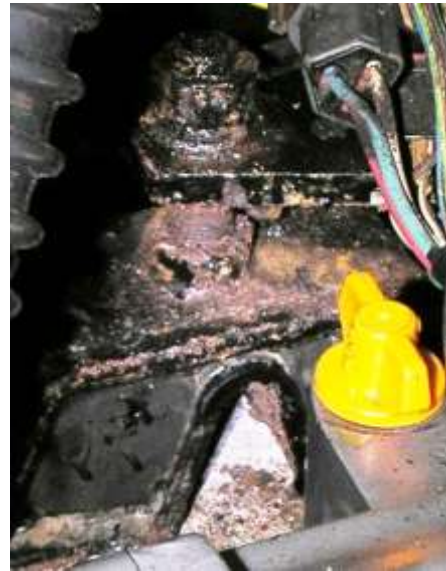
The auxiliary engine installation we found in good order generally with the exception of of the port aft engine flexible mount which appears to be heavily corroded.

Investigation require to identify the reason  
For the corrosion.

Removal of the engine mount to clean and paint  
or replace if required.

**Defects:-** 1) Investigate the cause and rectify the port aft auxiliary engine mount as required.  
2) Service auxiliary engine installation and related components as required.

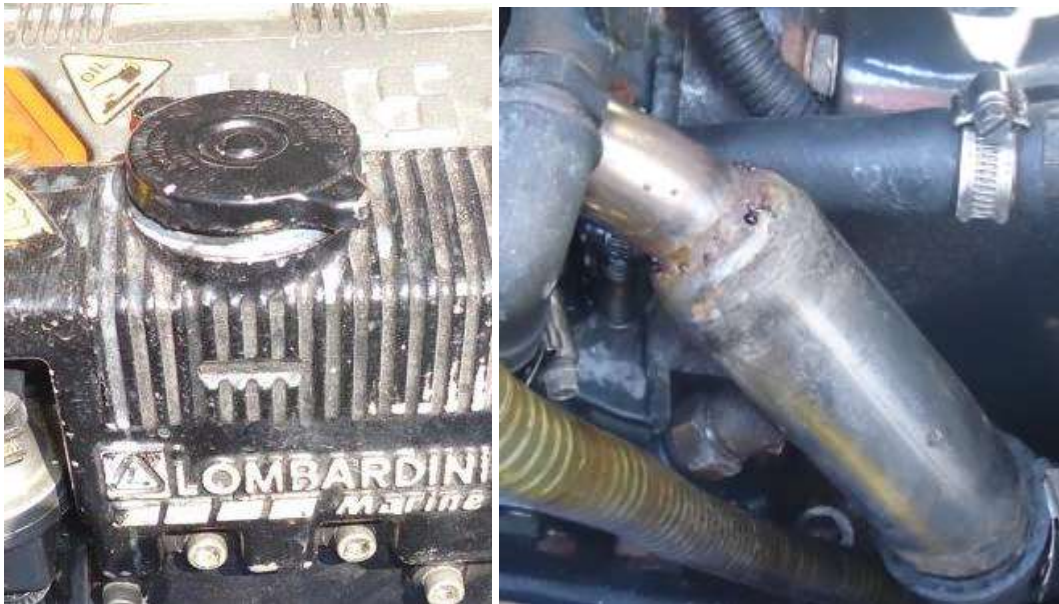
- Engine oil level was acceptable , oil was found in a dirty condition.
- Cooling water level acceptable.
- Generator was found to start easily and cleanly however no electricity was produced.
- Exhaust header/water injection unit suspect and requires investigation.
- Cooling header tank cap fitting is suspect,

***It is recommended that the services of a Mechanical/Electrical engine are sourced to control and service the generator as require.***

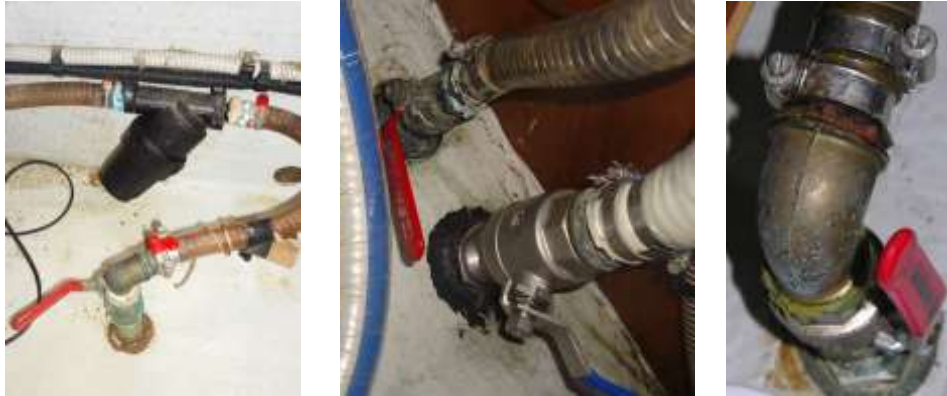
Certain hose and clamp concerns were noted and a mixture of metals which could result in bi-metal/galvanic corrosion which could affect the safety of the yacht.

*Air-con intake seacock and strainer concerns – Mixture of metals concerns*

Forward head: Two(2) bronze/brass ball valves of thruhull for head intake and sink drain. The head discharge seacock appears to have been replaced with a stainless steel ballvalve. (centre photo) in other instances it appears that stainless steel ballvalves have been fitted retaining brass/bronze thru-hulls and tail pieces.

- Defects:-**
- 1) Investigate and rectify as required the air-con rawwater cooling seacock, strainer, connections and hoses located under the centre cabinsole panel in the maincabin.
  - 2) Investigate seacocks, seacock hoses, connections and clamps and service as required.
  - 3) Correct and rectify mixed metal situation which exists by changing all seacocks to the same metal or consider composite seacocks except in the engine space.

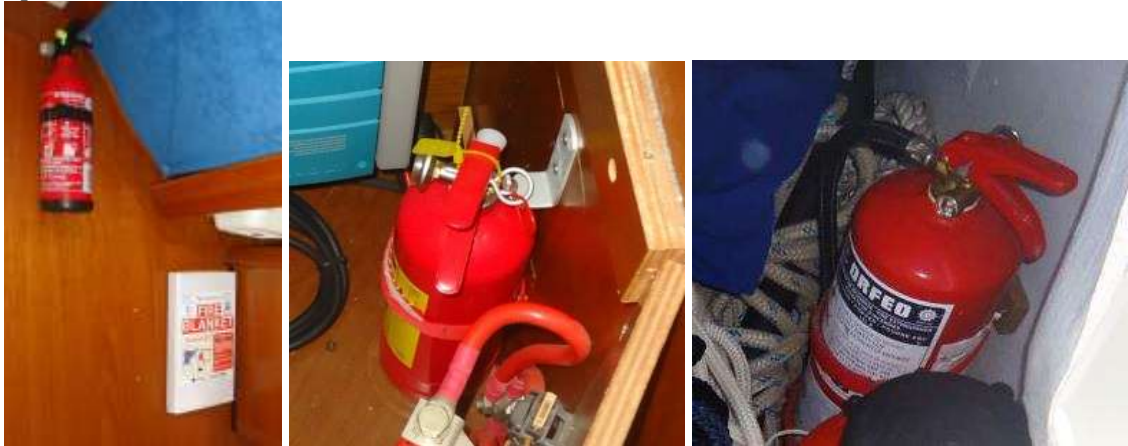
Certain fire extinguishers and fire blankets are mounted out of sight; therefore it is prudent to have to have plaques mounted in clear sight indicating the location of the protection equipment.

**Galley (note smoke alarm) – Under Chart table seat – Port cockpit locker**

- Smoke Alarms:-** All cabins fitted with battery powered smoke alarms  
\* non-operational.
- Defects:-** 1) Certain fire extinguishers and fire blankets are mounted out of sight;  
Therefore, it is prudent to have to have plaques mounted in clear sight  
indicating the location of the protection equipment.
