**Marine Surveys & Consultancy International**

**CONDITION SURVEY**

**Name of Vessel:-** "Sample"  
**Registration Number:-** TBA  
**Port of Registry:-** TBA  
**H.I. Number:-** FR-1R100588A303  
**Type of Vessel:-** Aux/Sail  
**Builder/Yard:-** Jeanneau (FRA)  
**Construction:-** GRP  
**Designer:-** Philippe Briand /Jeanneau  
**Place & Year Built:-** Les Herbiers, France, 2003  
**Length:-** 13.73m      **Beam:-** 4.49m      **Draft:-** 1.83m  
**Displacement:-** 21208 lbs./ 9620 kgs.      **Sail Area:-** 800 ft<sup>2</sup> / 74.32 m<sup>2</sup>  
**Gross/Net Tonnage:-** 18.05 Tons

**Location of Survey:-**      Afloat & Ashore  
Porto Touristic Marina di Ragusa, Sicily, Italy

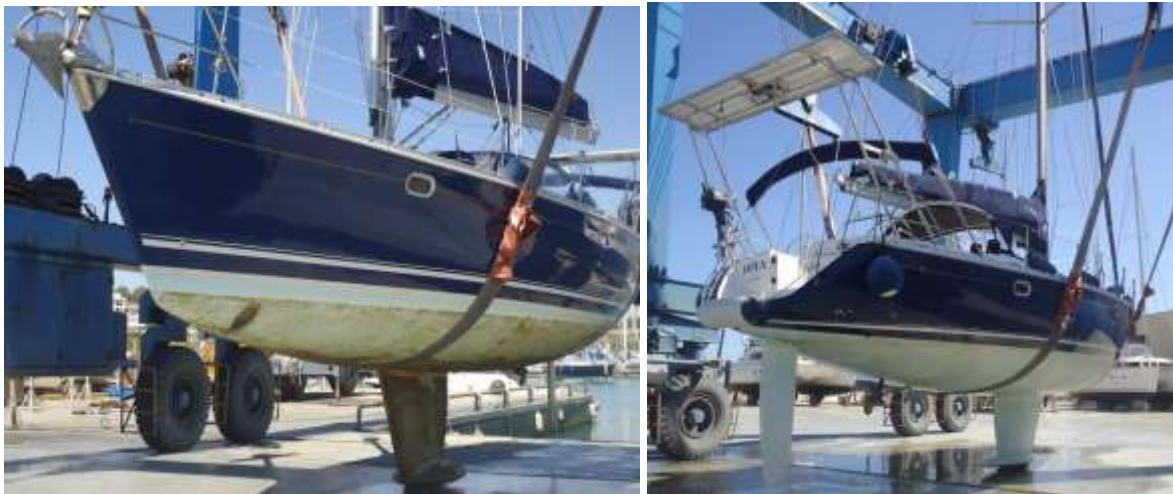
*Before and After pressure wash*

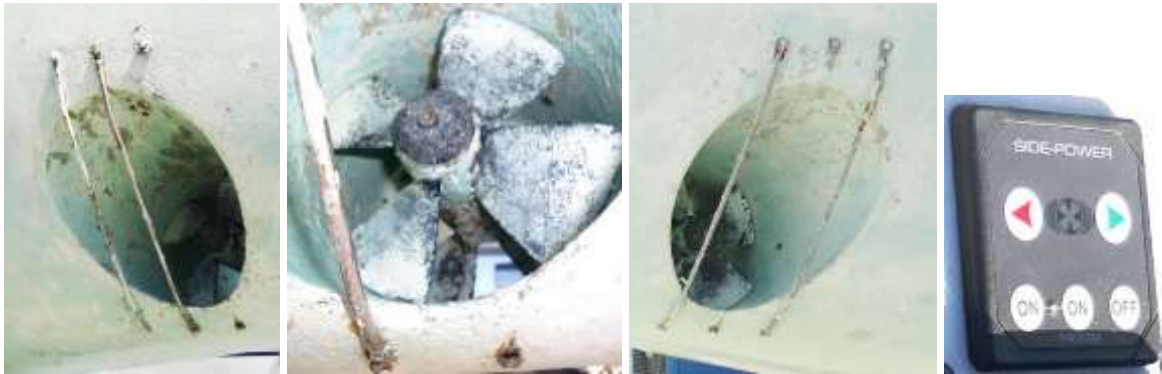
The yacht was observed to be fitted with a Side-Power bowthruster found in an operating condition. Control panel is located outboard at starboard helm position.

- + Propeller zinc anodes will require replacing at next haul-out.
- + Missing guard rails to be replaced at next haul-out.

- 1) Investigated rear 18mm keel stud and nut and rectified at the next haul-out.
- 2) Clean bilges as priority.
- 3) Investigate and check forward keel studs and nuts.
- 4) Bowthruster propeller zinc anodes will require replacing at next haul-out.
- 5) Bowthruster missing guard rails to be replaced at next haul-out.
- 6) Investigate and rectify corrosion concerns on keel at next haul-out.

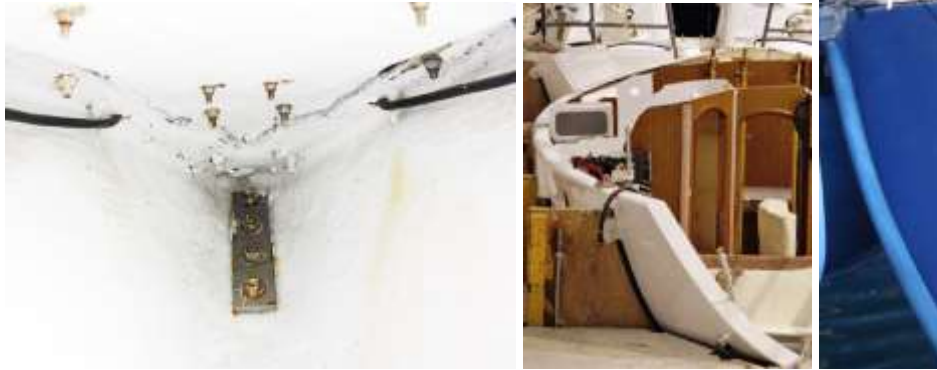
The photo below indicated that the hull to deck joint is of the inboard flange type as the photo from Jeanneau indicates. Provide strictly as information of indicated construction.

*Interior bow view – Jeanneau Photo – Transom detail*

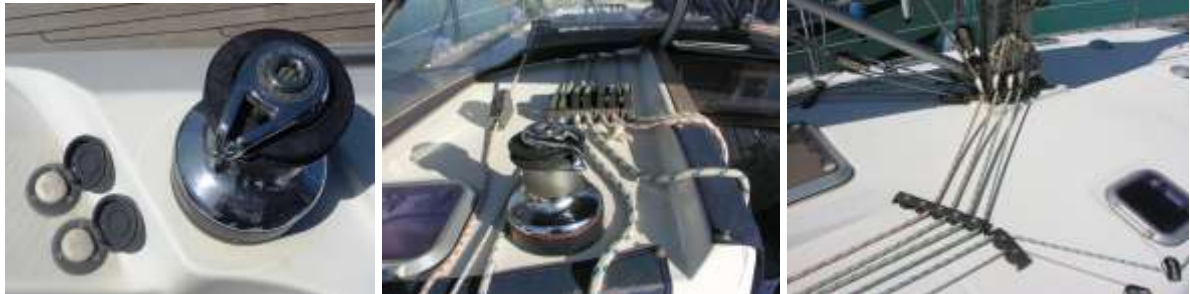
The following winches were observed in working condition:-

Note:- *minor damage noted to deck organizer to port.*

**Recommendations:-** Service winches and related equipment as required.

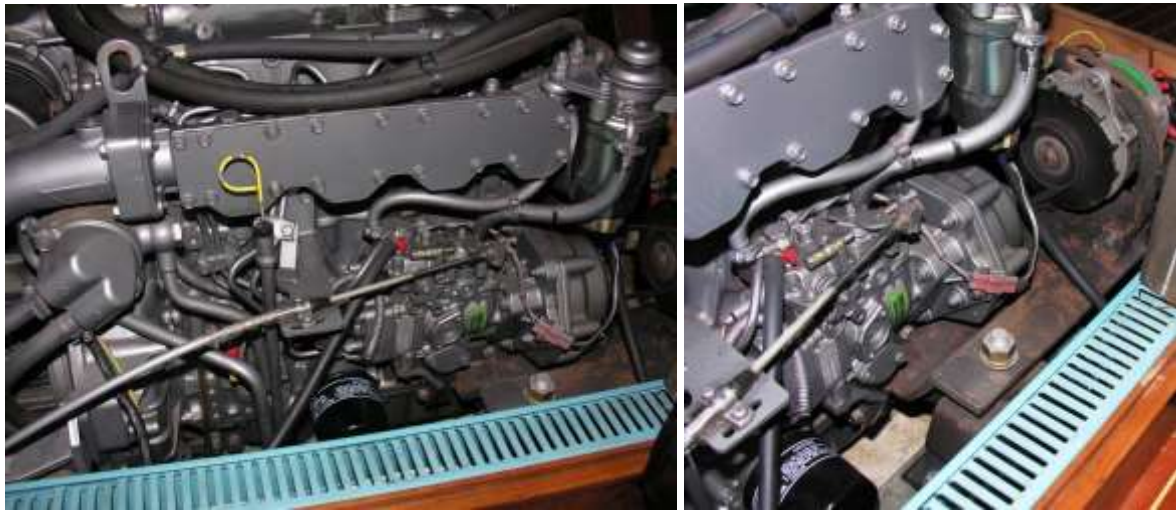
*Starboard views note auxiliary generator*

The auxiliary engine installation we found in good order generally with the exception of of the port aft engine flexible mount which appears to be heavily corroded.

Investigation require to identify the reason  
For the corrosion.

Removal of the engine mount to clean and paint  
or replace if required.

**Defects:-** 1) Investigate the cause and rectify the port aft auxiliary engine mount as required.  
2) Service auxiliary engine installation and related components as required.

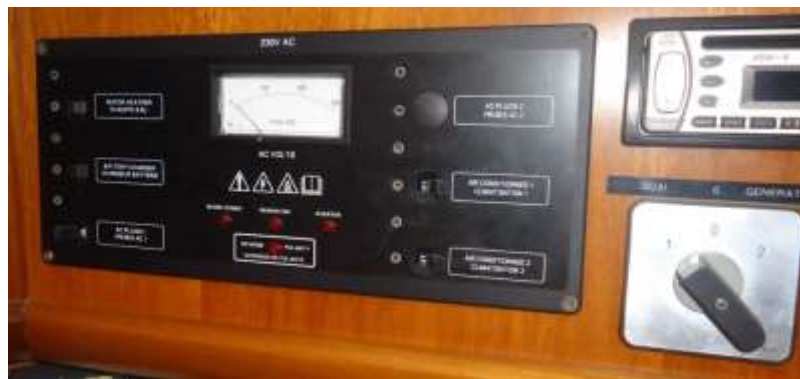
Note: supply selector switch to the right of the shorepower distribution/breaker panel.

No testing of the shorepower system has been carried out.

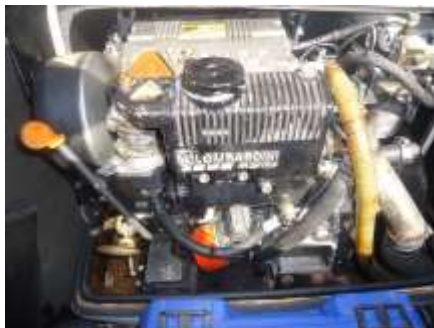
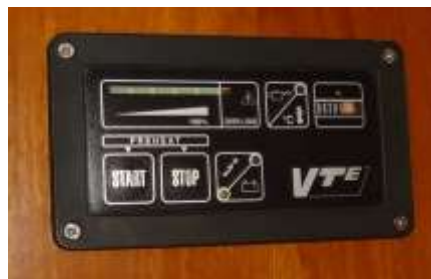
The yacht was observed to be fitted with a Paguro 6000, 6KVA marine generator in a sound insulated cover located in the starboard cockpit locker. Unit by Bombardini Marine with a type LDW 502M diesel engine with indirect cooling. Recorded 204,83 engine hrs.

- Engine oil level was acceptable , oil was found in a dirty condition.
- Cooling water level acceptable.
- Generator was found to start easily and cleanly however no electricity was produced.
- Exhaust header/water injection unit suspect and requires investigation.
- Cooling header tank cap fitting is suspect,

***It is recommended that the services of a Mechanical/Electrical engine are sourced to control and service the generator as require.***

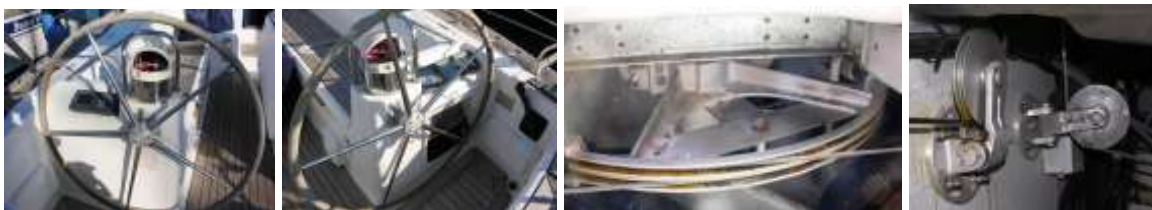
The yacht was observed to be fitted with dual station wheel/ cable steering system by Goiot. The leather covered wheels operate 6mm 7 X 19 stainless steel cables via aluminum turning blocks/sheaves to aluminium quadrant mounted on 6cm stainless steel rudder shaft.

The system was found to be operational however all areas require service and lubrication including auto-pilot linkage found dry and with signs of minor corrosion.

**Recommendations:- Service steering system as required**
